STRUCTURAL ASSESSMENT for the CENTENNIAL BAPTIST CHURCH

Helena, Arkansas

March 19, 2021

Structural Assessment by STRATA Architecture Inc. and Structural Engineering Associates, Inc.

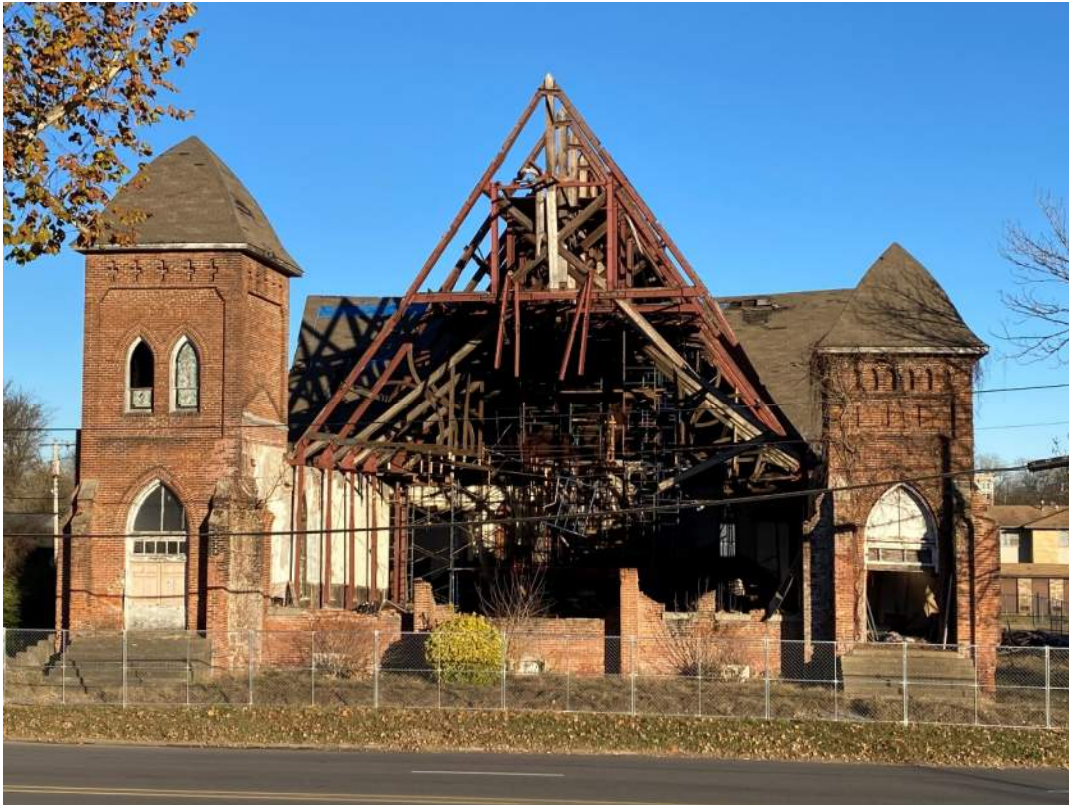
Figure 1.1. Centennial Baptist Church, after April 2020 storm. (STRATA December 2020)

With the church building in a precarious state, there is a sense of urgency to determine a path forward for stabilization and to study options for the future of this historic site. The purpose of this report is to document damage that resulted from the high wind event and to explore

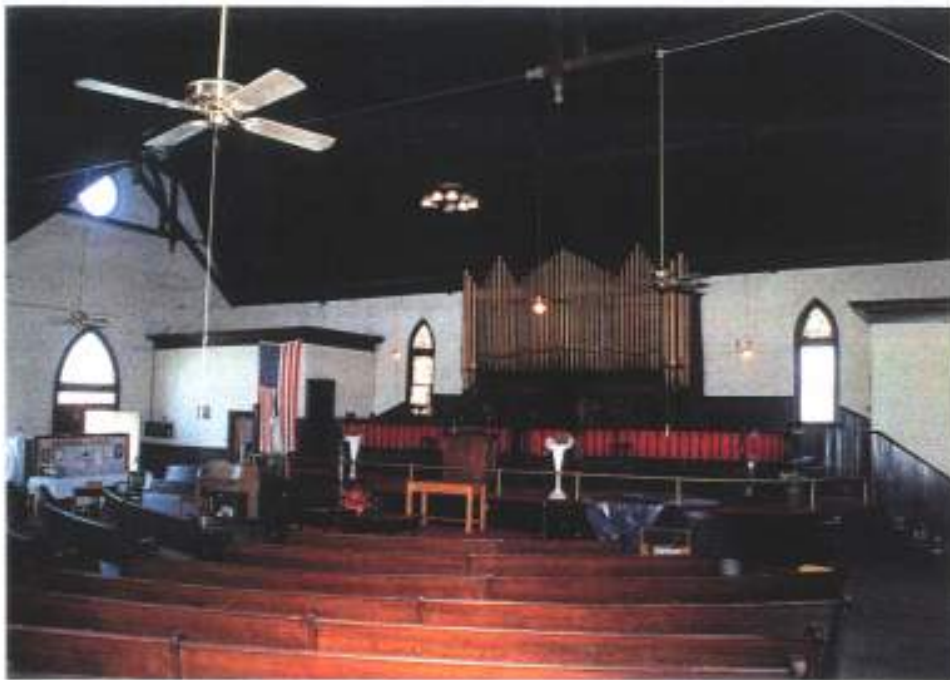
1905	Church constructed.
1987	Centennial Baptist Church listed in the National Register of Historic Places.
1993	Assessment for stabilization work began by Jameson Architects and ICE Inc. Consulting Engineers.
1994	The E.C. Morris/Centennial Church Preservation Committee formulated to gain broader support to restore Centennial. ⁴
1994	Funding from the Arkansas Historic Preservation Program and Arkansas Humanities Council was provided. ⁵
July 1994	“Emergency Stabilization and Rehabilitation Feasibility Report – Centennial Missionary Baptist Church” by Borne & Jameson Architects PA, and ICE Inc. Consulting Engineers, Little Rock, for the Centennial Church Restoration Committee. Report guided the first emergency stabilization project. This report identified failing trusses, bowing walls, deteriorated soffits, water infiltration, failed roof flashing, failed roofing, masonry deterioration, window and door deterioration and missing elements, and water infiltration into the interior. (Figures 1.4 – 1.6)

Figure 1.4. Interior view of the sanctuary looking east. (Photograph from the 1994 Jameson report).

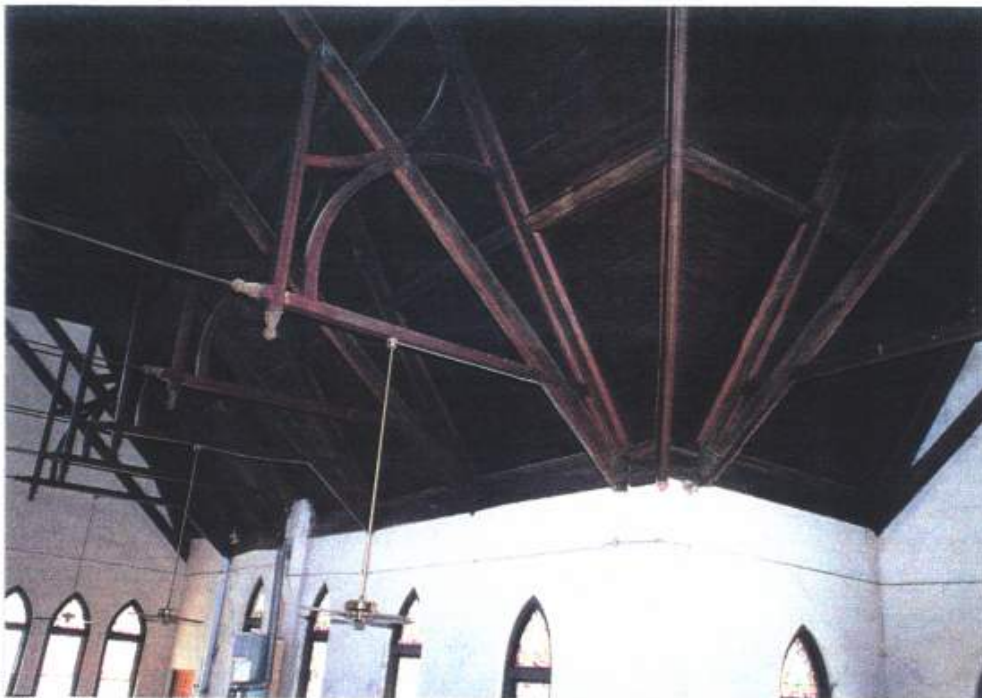
Figure 1.6. Typical roof trusses where the transept and nave meet, looking northwest. (Photograph from the 1994 Jameson report).

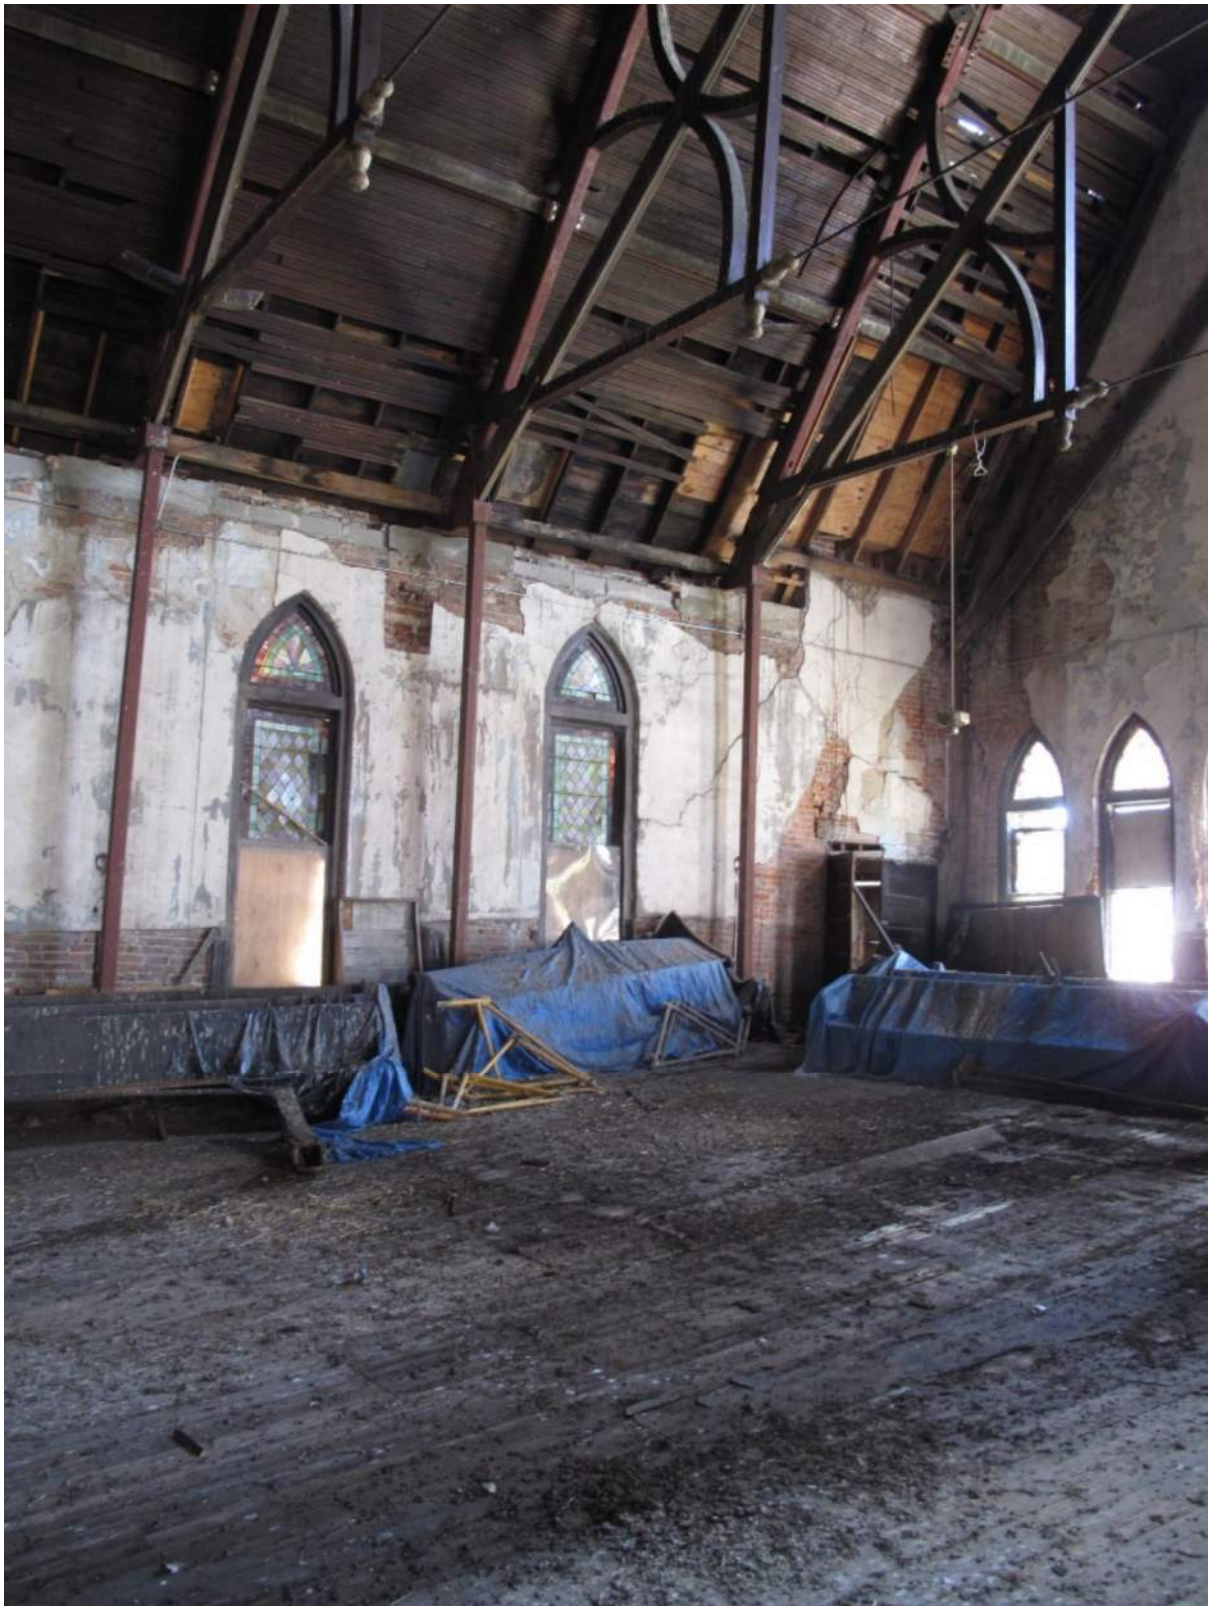
Figure 1.9. Trusses T-1, T-2, and T-3 stabilized, looking southwest.
(Photograph by Jameson Architects PA, August 2, 2017).

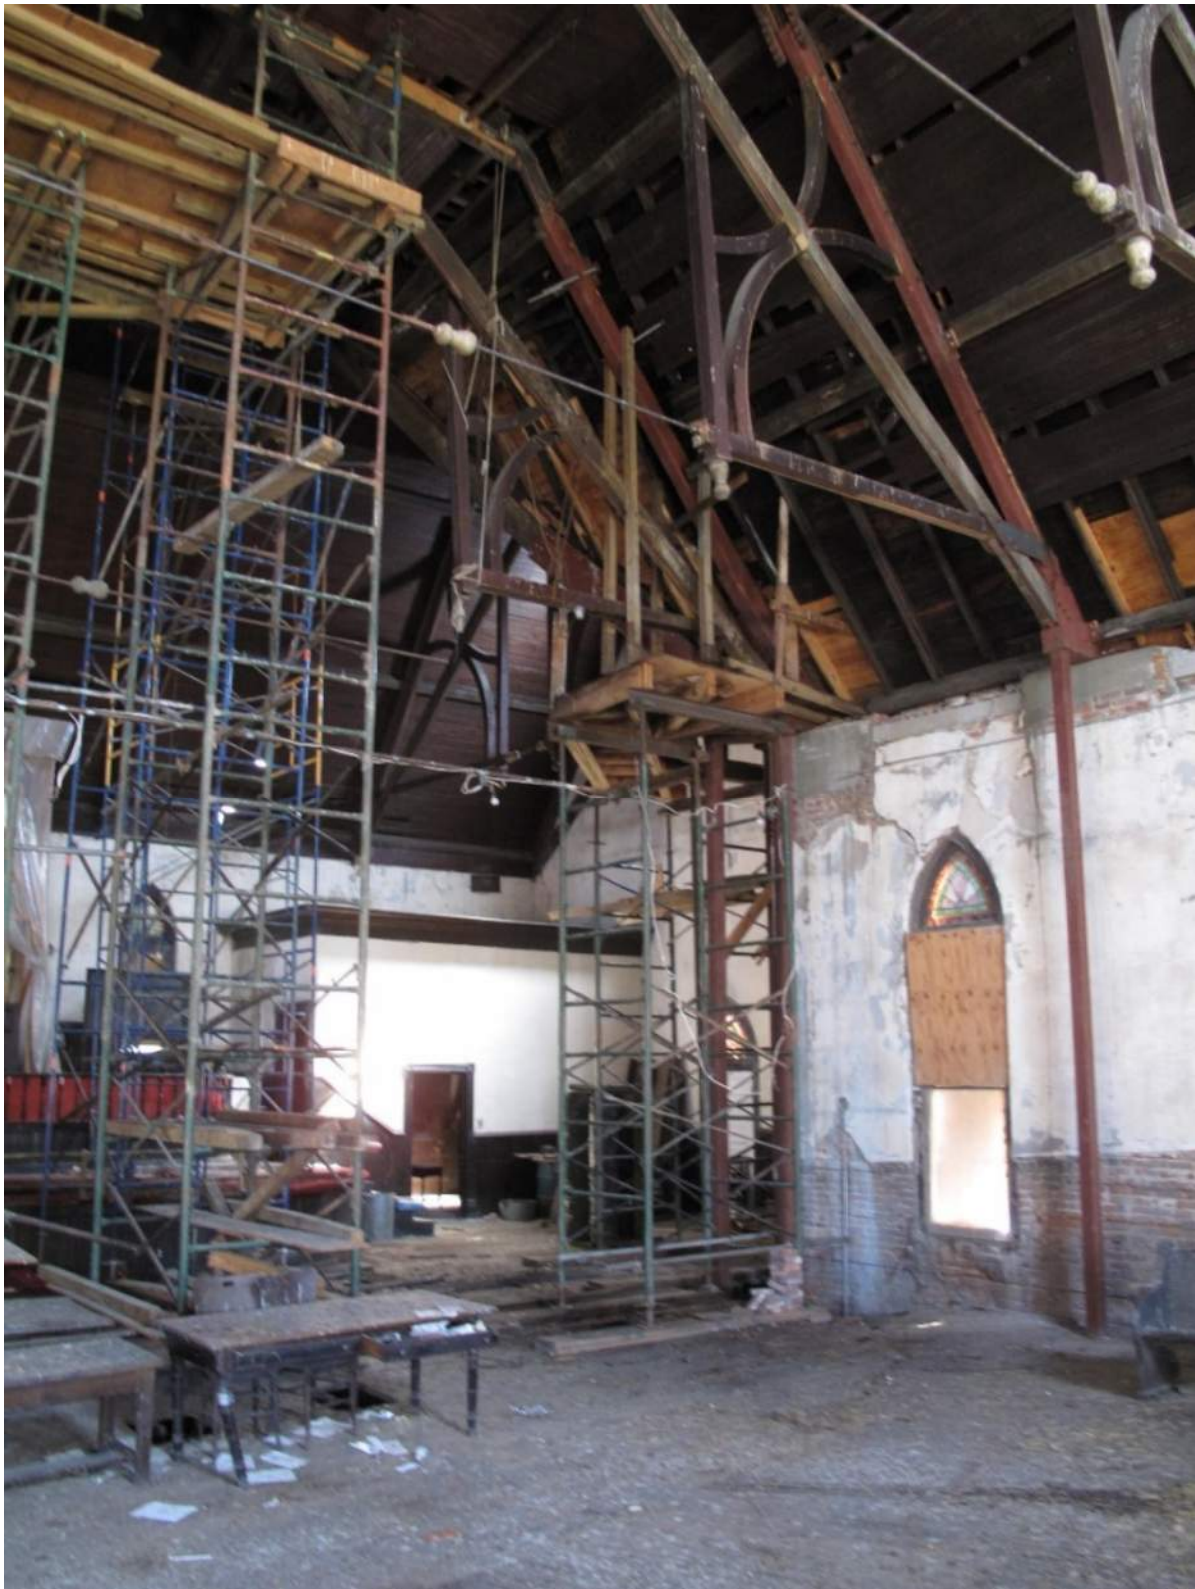
Figure 1.10. Truss T-4 (stabilized in the foreground) and Truss T-5 in the midst of stabilization with scaffolding. (Photograph by Jameson Architects PA, August 2, 2017).

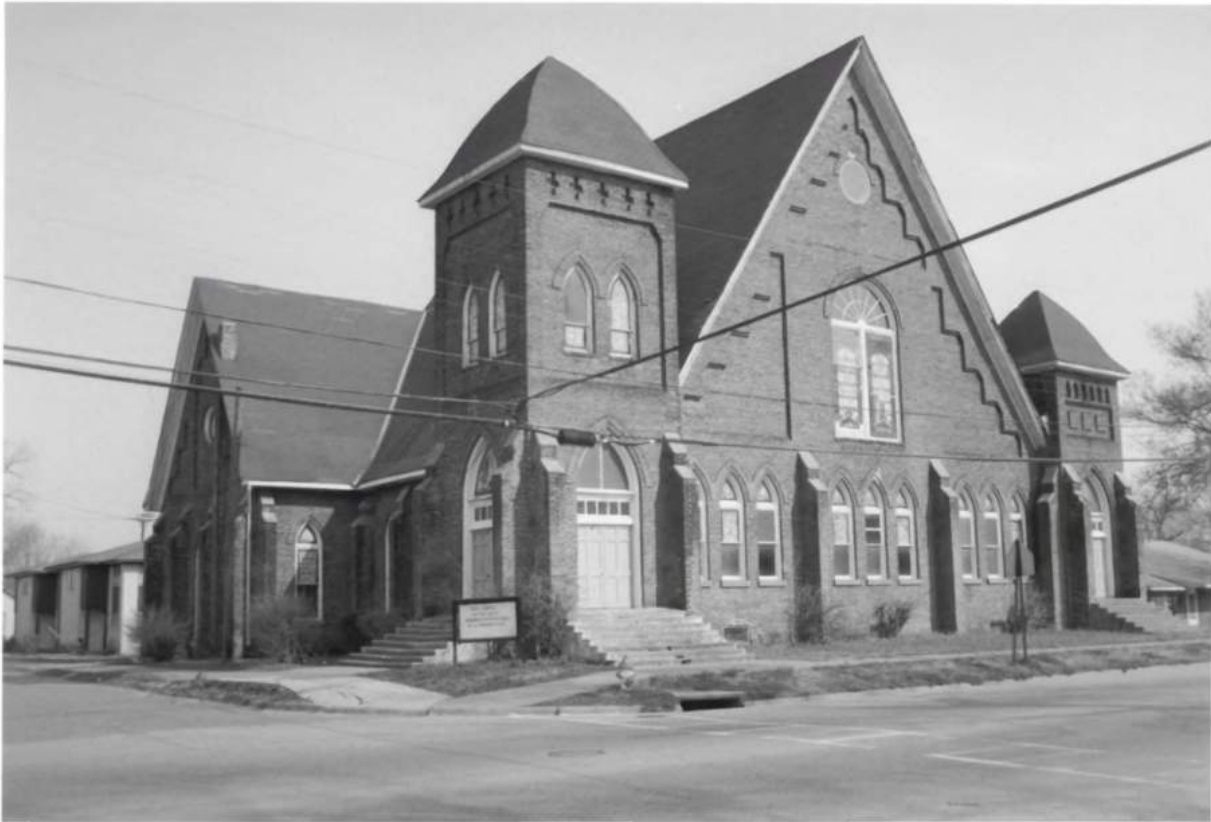
Figure 2.2. Centennial Baptist Church west façade and north wall. (National Historic Landmark nomination photograph, 2000)

The church is T-shaped in plan, with the nave on the west, and the transept on the east. The nave has a very tall, steeply sloping gable roof with the ridge running east-west. The transept also has a steeply sloping gable roof, but shorter, and running north-south. The church faces west toward Columbia Street. The façade featured a large brick gable, now collapsed. The remnants of this wall are flanked by two towers with entrances to the church. The north tower is taller than the south tower and has stained glass windows above the doors (Figure 2.2).

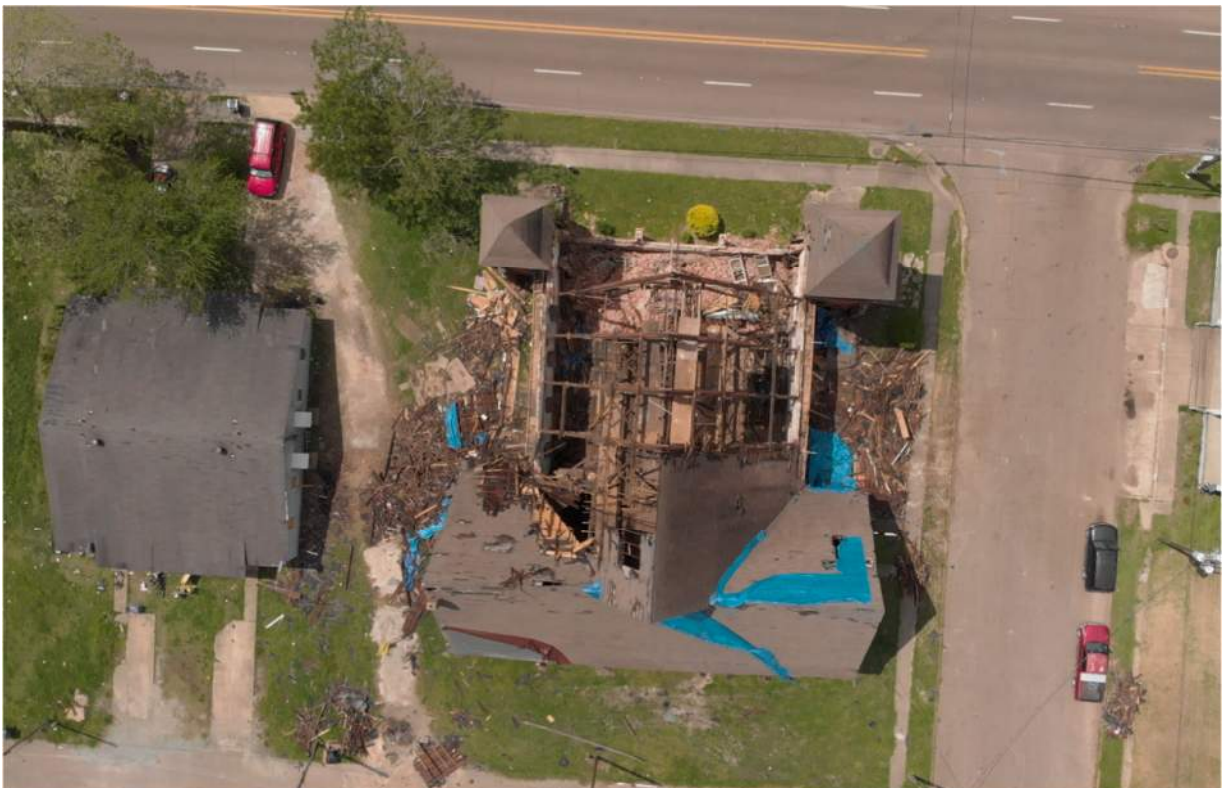
Figure 3.2. Drone photo following collapse. (Courtesy Amoz Eckerson 2020)

The stabilization process would likely begin with careful removal of debris from around the exterior perimeter of the building and site to allow access to the structure for dismantling the roof framing (Figure 3.2). Debris removal should only be performed in good weather with no or very low winds. Very low winds for this purpose would be defined as 15 mph or less.

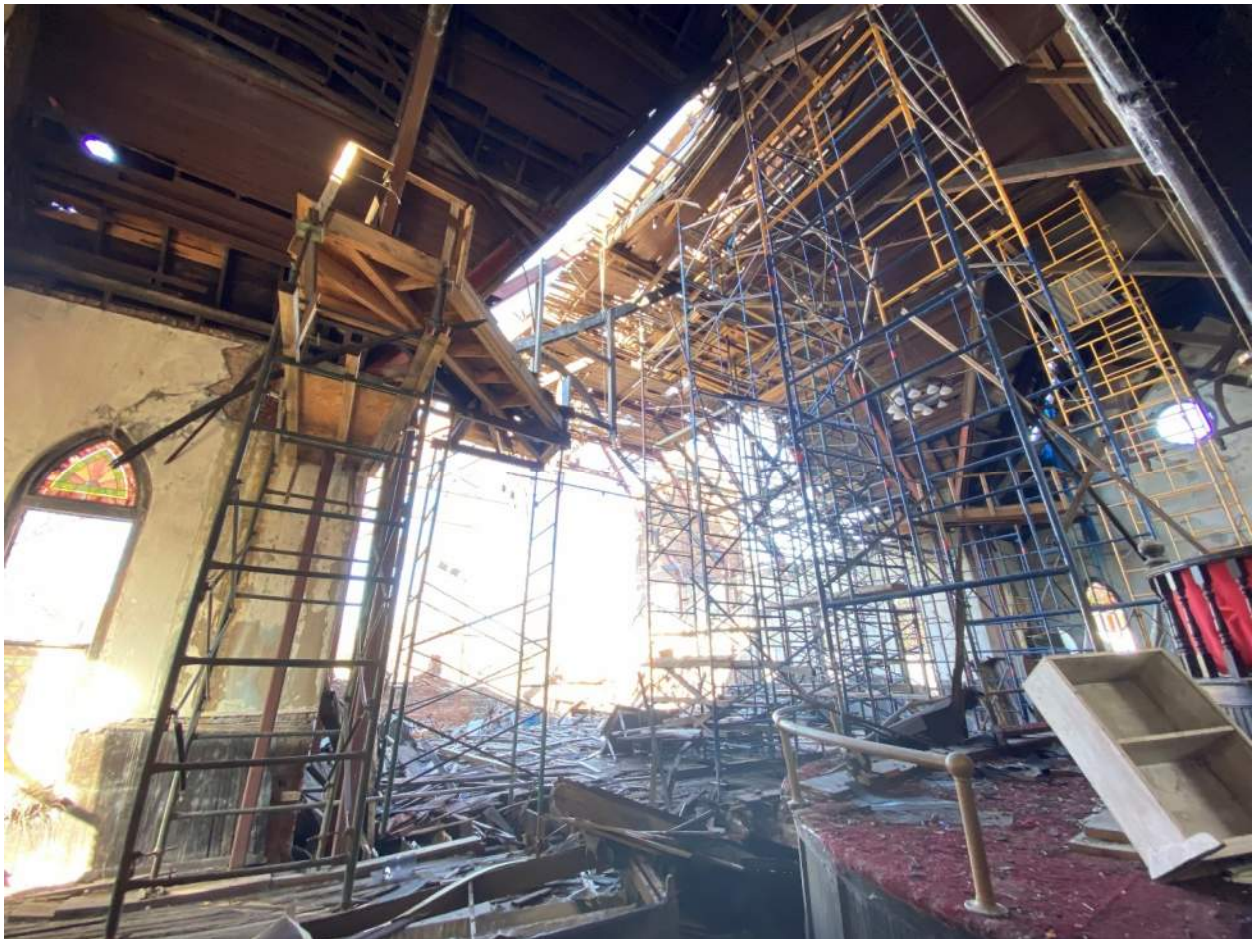
Figure 3.5. View of scaffold from inside transept. (STRATA 2020)

It should also be noted that the condition of the scaffolding within the church is precarious and any connections to the trusses above are unclear. It is presumed that the scaffold would be dismantled in conjunction with removal of the trusses, at least down to a level that would be accessible by aerial lifts reaching from outside of the structure (Figure 3.5).

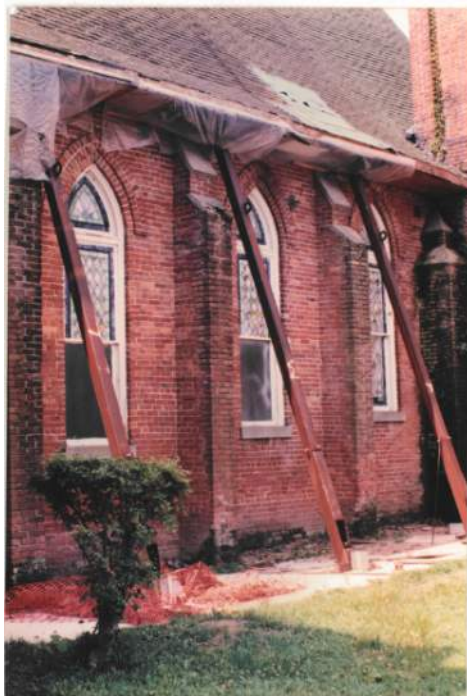
Figure 3.8. Previous bracing for the north wall, since removed. (Courtesy Tommy Jameson)

analysis of the existing braces should be performed to determine if they are adequate to resist the wall falling inward. Temporary bracing (now removed) had been installed for the north wall of the nave during the previous truss stabilization efforts (Figure 3.8). Similar bracing would be used for the remainder of the transept and nave walls. The new bracing would have more members compared to the existing bracing, and feature waler beams on the interior face of the walls. It is unclear from visual observations or from documents previously provided if the floor of the crawlspace is at or below the elevation of exterior grade. It is presumed that the floor of the crawlspace is below the level of exterior grade, and another component of bracing would be needed lower on the interior face to resist lateral earth pressures.
